# Manhole Inspection Summary

Manhole # S31UU\_040MH

Insp Date: **5/9/07 10:56 AM**

**Location** Address: **301 29TH ST**

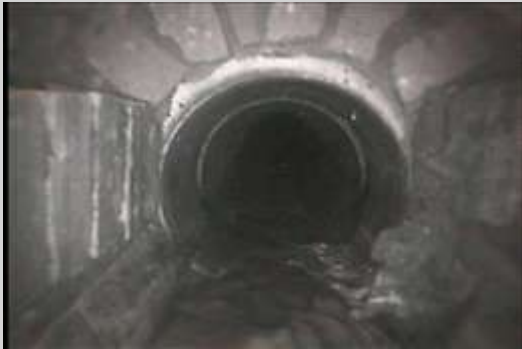
### 8 in. Circular Gravity Sewer Pipe Out @ 12 O'Clock

Pipe Material: **Clay** ☐ Pipe Lined

Invert Depth: **10.43** (ft.) Flow Characteristics: **Slow**

Deposits: ☒ None ☐ **Mud** ☐ Sludge ☐ **Debris** ☐ Grease

Infiltration: **None** Pipe Seal Cond: **Unknown**

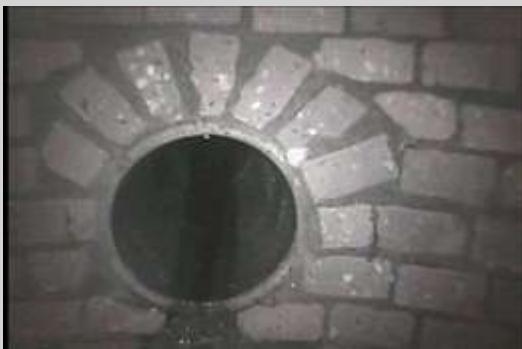
### 8 in. Circular Gravity Sewer Pipe In @ 3 O'Clock

Pipe Material: **Clay** ☐ Pipe Lined

Infiltration: **None** Pipe Seal Cond: **Sound**
